Welney Sports Pavilion and Community Centre

Structural Inspection of Sports Pavilion and
Centre off Herne Drove, Welney, PE14 9SD

Structural Inspection of building

November 2017

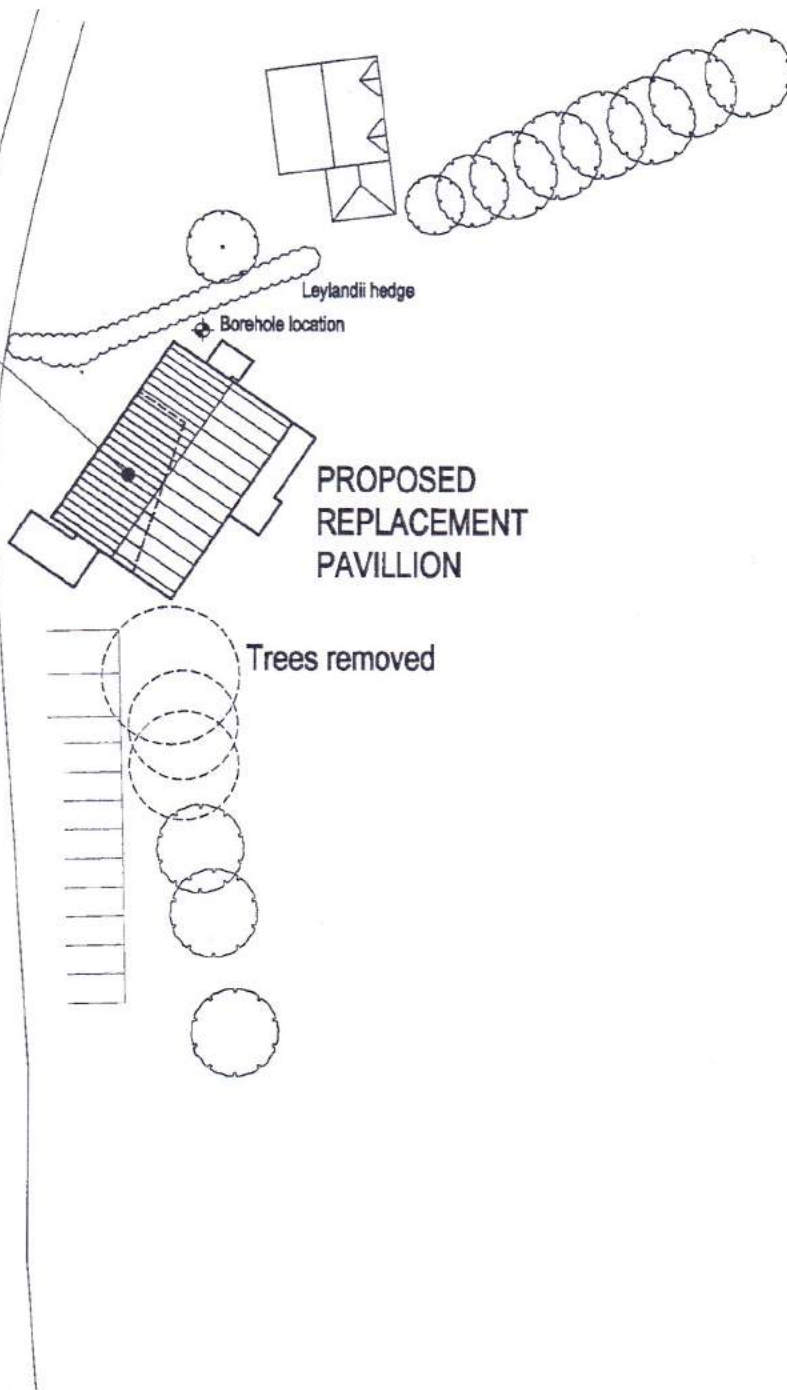
Sketch
SITE PLAN

- 3.2** We partially removed a small amount of the timber cladding at the North East and South East corners to expose the foundation arrangement. Whilst visibility and access to the void beneath the suspended floor was limited due to the plastic drain pipe around the building perimeter and the general lack of space beneath the ground floor, it was evident that the building is constructed on two different foundation systems. Part of the building appears to be constructed on the concrete slab that previously supported the old timber pavilion building and in the area where there was no slab, the steel jacks were supported on 600 x 600 paving slabs which sit directly on the grass and topsoil of the cricket ground. Refer to the site plan in Appendix A which shows the approximate extent of the different foundation systems.

- 3.5** We excavated a 300mm x 300mm x 350mm deep trial hole and a 50mm diameter hand augured borehole at the Northern end of the pavilion to identify soil conditions on the site. The excavation revealed 350mm of brown clay topsoil containing abundant live roots, overlying a 100mm band of soft to firm grey, brown clayey silt /silty clay overlying very soft black clay containing peat bands. The borehole was terminated at 1.2 metres below ground still in very soft clays. The borehole location is indicated on the site plan in Appendix A.

- 3.6** The pavilion has been located in close proximity to a large Leylandi hedge, which at the North West corner of the building is only 1 to 1.5 metres away. There is a mature broadleaf tree in the neighbouring garden which may also impact the building foundations and we understand numerous mature trees which were in close proximity to the pavilion have been removed. Tree locations are shown on the site plan in Appendix A.

Shaded area indicates
extent of old concrete
slab.

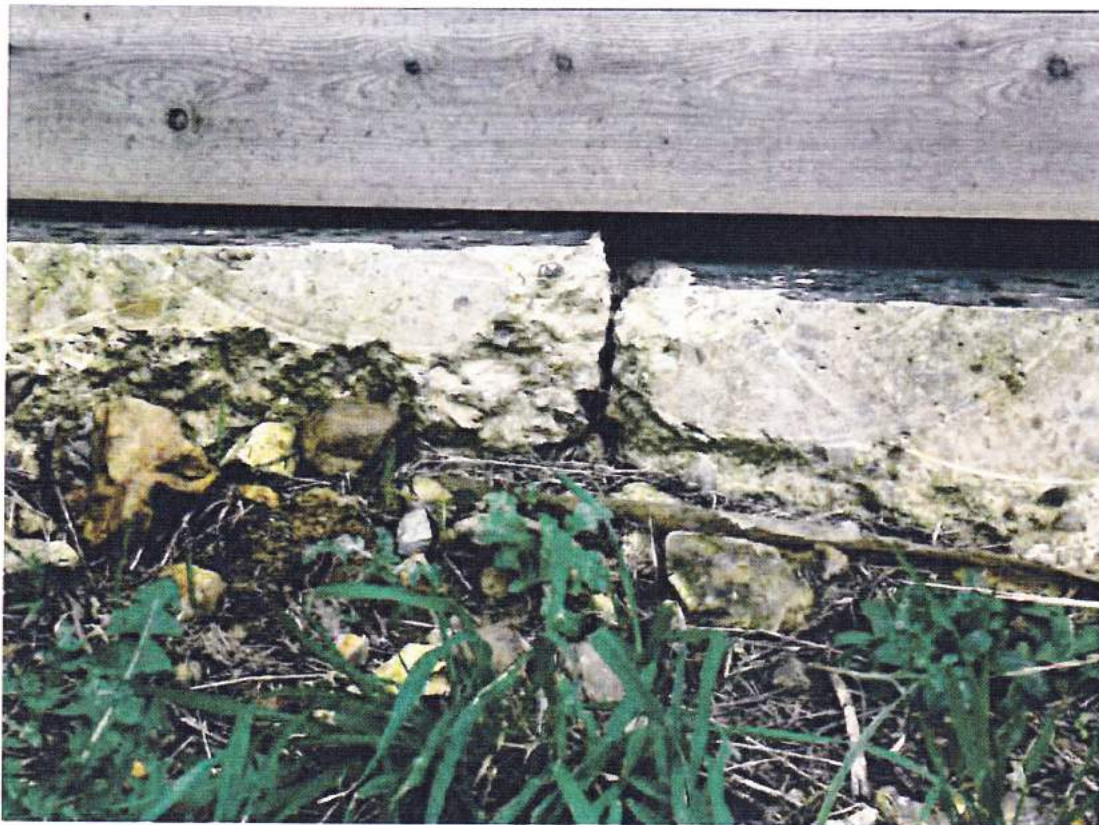
Plate 1

- 3.3** The old concrete slab varies in thickness from 75 to 150 mm and cracks in the slab are clearly visible along the West elevation of the pavilion. The slab edge slopes noticeably and it is clear that the slab has settled significantly over the years. See plates 1, 2 and 3 in Appendix B.

- 4.3 The old concrete slab that has been used to support part of the pavilion is not adequate. It has substantial cracks in places and slopes quite dramatically, indicating that at some point it has failed. The slab may however act as a hard spot as it will distribute the foundation point loads more effectively than the isolated paving slabs - this may result in differential foundation movements which may further exacerbate the movements and damage related to the isolated pads.

- 5.1 To arrest the movement permanently and have confidence that the building is adequately supported it would be necessary to install a new foundation system. The most appropriate foundation solution would be a piled system which would transfer the loads to suitable ground at depth and also take due account of potential ground movement issues relating to the trees.

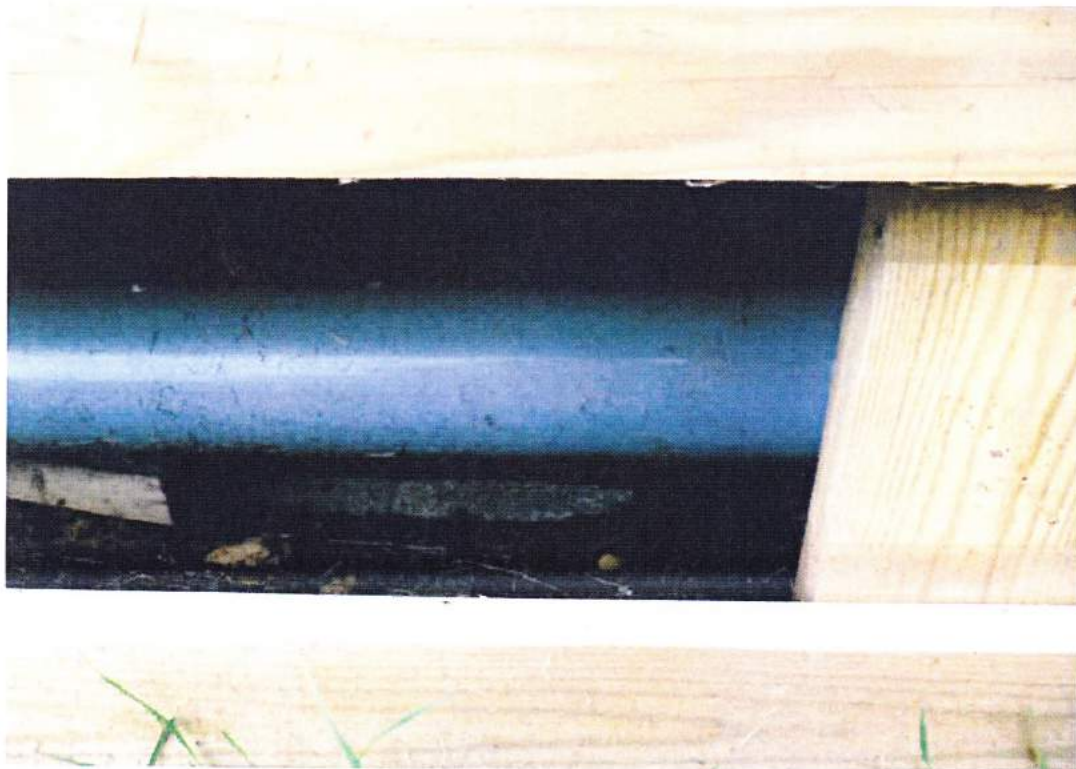
Plate 4

- 3.4** The isolated paving slabs used to support the building are 600mm x 600mm plan area and 50mm thick. In many instances the slabs are stacked two high but at the North East corner the steel jack rests on a single paving slab. We are advised that MRC, the suppliers of the building, have been to site to repair several single paving slabs that had cracked and these were subsequently replaced with the double slab arrangement. At the time of our inspection there were several broken slabs lying around in the void beneath the building and these are presumably the above mentioned failed slabs. Refer to plates 4 and 5.
